NASA-CR-159622  
LYC 79-25

**FINAL REPORT**

**DEVELOPMENT OF SPIRAL-GROOVE  
SELF-ACTING SEALS FOR  
HELICOPTER ENGINES**

**AVCO LYCOMING DIVISION**

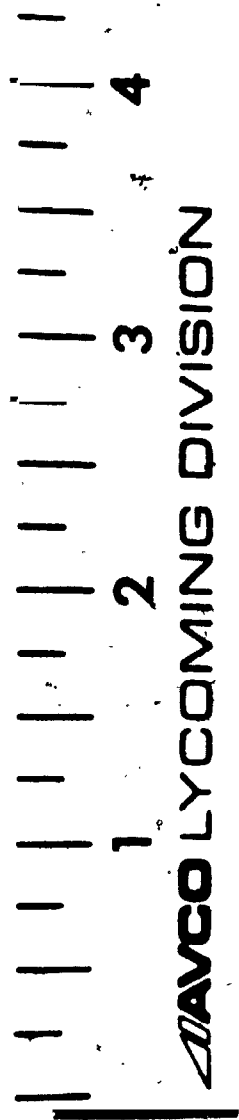
Figure 9. Assembled Seal, After Start-Stop Test.

The posttest appearance of the seal components is shown in Figure 9 (overall appearance), Figure 10 (close-up of primary sealing element), and Figure 11 (close-up of the seal seat).

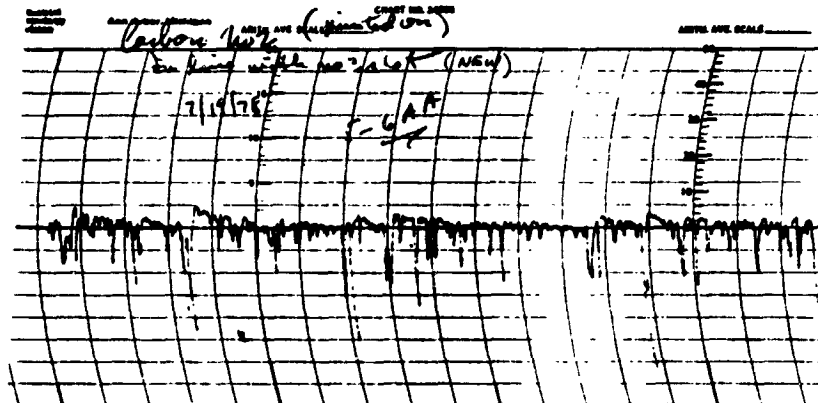
PRIOR TO RUN 0 (NEW)

**PRIMARY SEALING ELEMENT  
NO. 2 SURFACE FINISH**

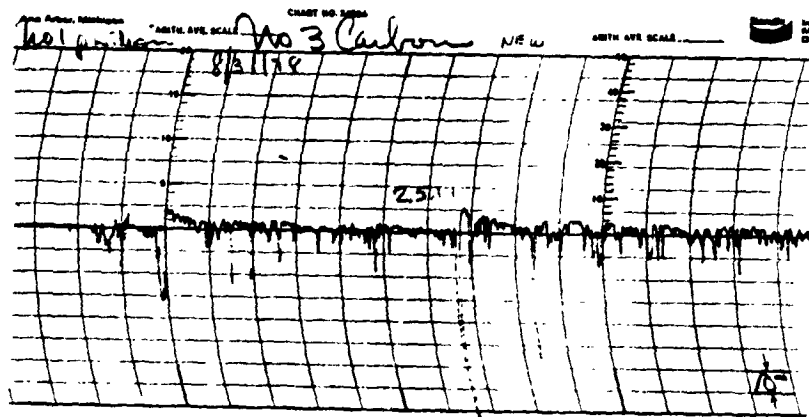
PRIOR TO RUN 16 (NEW)

PRIMARY SEALING ELEMENT  
NO. 3 SURFACE FINISH

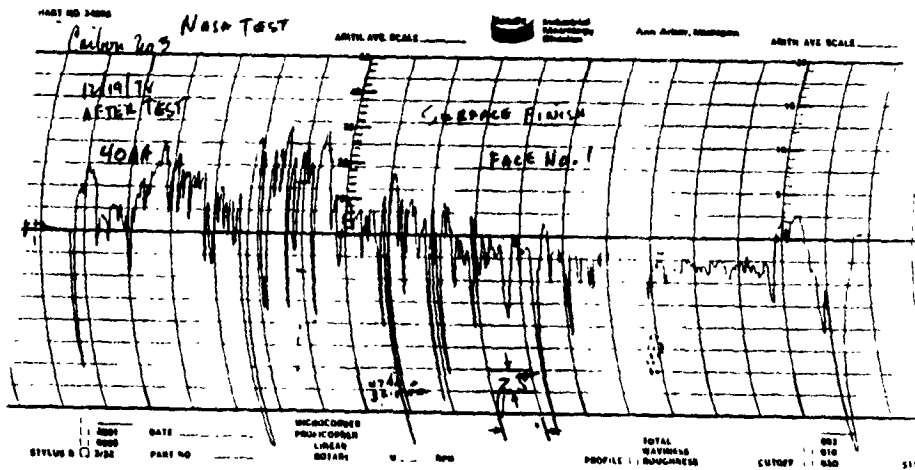
AT END OF ENDURANCE TEST

- Significant variations in primary sealing element surface profile were observed during testing, and will result in seal operation with non-flat surfaces on primary sealing element. This may be due to abrasive wear or could be related to the suspected binding between the primary sealing element and seal housing.
